SEM Observations of Fracture Surfaces of Fatigue Specimens of Annealed Type 316 Stainless Steel

F. A. SMIDT, JR., AND V. PROVENZANO

August 10, 1977

NAVAL RESEARCH LABORATORY Washington, D.C.

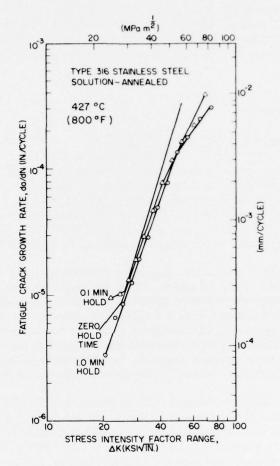
Fig. 2 — Effect of hold time on fatigue crack propagation rate da/dN in air at 427° C (800° F) for solution-annealed Type 316 stainless steel [3]

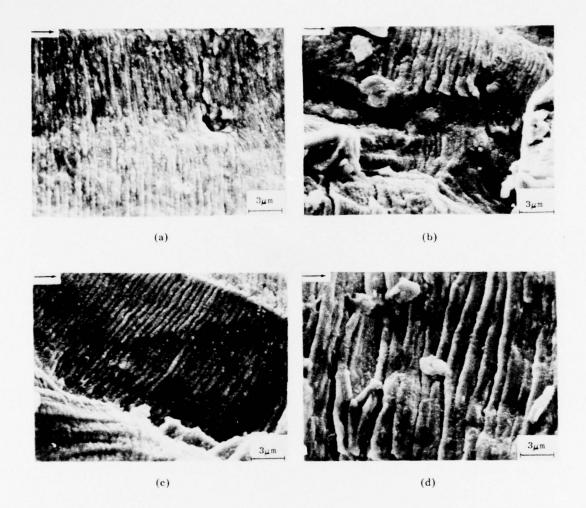
Consider first the solution-annealed material tested at 427° C (800° F). The crack growth rate data from the tests [3] is presented in Fig. 2. As can be seen in the figure, the growth rate per cycle increases from approximately 7.5×10^{-5} mm/cycle (3×10^{-6} in./cycle) at 22 MPa \sqrt{m} (20 ksi \sqrt{in} .) to about 3.8×10^{-3} mm/cycle (1.5×10^{-4} in./cycle) at 55 MPa \sqrt{m} (50 ksi \sqrt{in} .). In this range it approximates a linear behavior. At low magnifications the fracture surface shows a transgranular mode of failure with irregular topography from grain to grain. At high magnifications fatigue striations can be found on the surface, as illustrated in Fig. 3, for both low, $22 \text{MPa} \sqrt{m}$ ($20 \text{ ksi} \sqrt{in}$.), and high $44 \text{MPa} \sqrt{m}$ ($40 \text{ ksi} \sqrt{in}$.), ΔK regimes of the test. These striations are typical of those found in ductile metals [8] as a consequence of the alternate extension of the crack by shear and the subsequent compression of the crack tip region during the unloading part of the cycle. It is readily apparent that the striation spacings increase as one goes to higher ΔK values, and measurements of the striation spacing at both high and low ΔK show a close correlation with the calculated da/dN values. The imposition of a hold time had no noticable influence on either the crack growth rate, as can be seen in Fig. 2, or the appearance of the fracture surface, as can be seen in Fig. 4.

Fig. 3 — Fracture surfaces (SEM) of a solution-annealed stainless steel specimen tested at $427^{\circ}\mathrm{C}$ ($800^{\circ}\mathrm{F}$) with 0.1-min hold time. The SEM micrographs were taken at crack lengths that correspond to the following ΔK values: (a) $22~\mathrm{MPa}\sqrt{m}$ ($20~\mathrm{ksi}\sqrt{\mathrm{in.}}$), (b) $27.5~\mathrm{MPa}\sqrt{m}$ ($25~\mathrm{ksi}\sqrt{\mathrm{in.}}$), (c) $33~\mathrm{MPa}\sqrt{m}$ ($30~\mathrm{ksi}\sqrt{\mathrm{in.}}$), and (d) $44~\mathrm{MPa}\sqrt{m}$ ($40~\mathrm{ksi}\sqrt{\mathrm{in.}}$). Arrows indicate direction of macroscopic crack propagation. Transgranular features with distinct fatigue striations can be clearly seen in the micrographs.

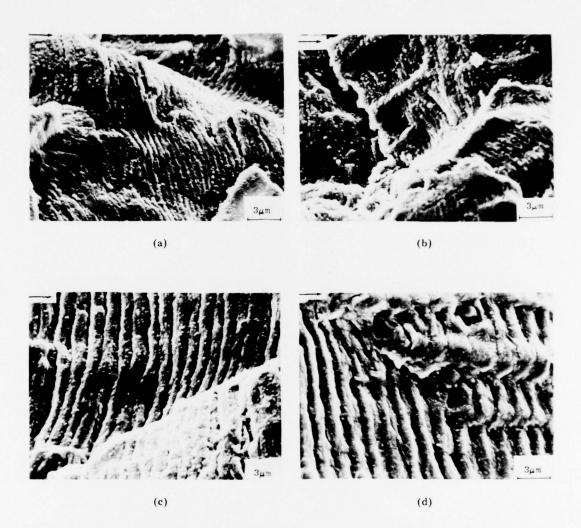
Fig. 4 — Fracture surfaces (SEM) of a solution-annealed stainless steel specimen tested at 427°C (800°F) with 1-min hold time. The SEM micrographs were taken at crack lengths that correspond to the following ΔK values: (a) $22 \text{ MPa}\sqrt{m}(20 \text{ ksi}\sqrt{\text{in.}})$, (b) $27.5 \text{ MPa}\sqrt{m}(25 \text{ ksi}\sqrt{\text{in.}})$, (c) $33 \text{ MPa}\sqrt{m}(30 \text{ ksi}\sqrt{\text{in.}})$, and (d) $44 \text{ MPa}\sqrt{m}$ (40 ksi $\sqrt{\text{in.}}$). Arrows show the direction of macroscopic crack propagation. As was the case for a hold time of 0.1 min, transgranular features with clear fatigue striations can be seen in the micrographs.

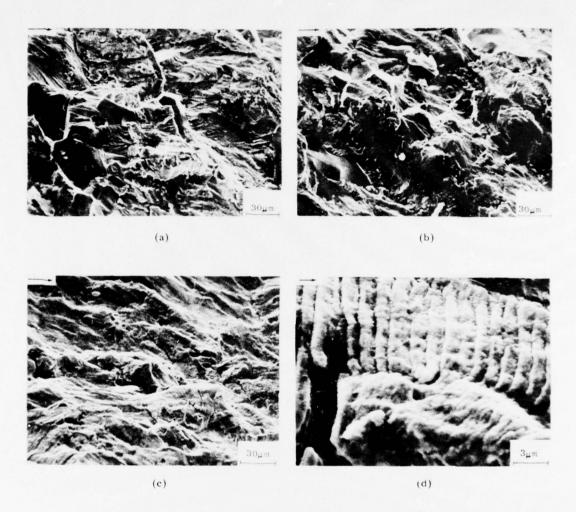
Typical SEM micrographs of the solution-annealed specimens tested at 593° C (1100° F) with no hold time are shown in Fig. 6. As in previous figures, these micrographs include representatives from regions of both low and high values of ΔK . For crack lengths up to 16mm (0.65 in.), which corresponds to a ΔK value of 33 MPa \sqrt{m} (30 ksi $\sqrt{\text{in.}}$), the failure mode was mixed, containing areas where intergranular failure, as well as the more predominant transgranular failure mode, was clearly evident. At ΔK values above 33 MPa \sqrt{m} (30 ksi $\sqrt{\text{in.}}$), the failure mode was transgranular, and clear striations were observed, as shown in Fig. 6.

Fig. 6 — Fracture surfaces of a solution-annealed Type 316 stainless steel specimen tested at $593^{\circ}C$ ($1100^{\circ}F$) with zero hold time. The SEM micrographs were taken at crack lengths that correspond to the following ΔK values: (a) $22~\text{MPa}\sqrt{m}$ ($20~\text{ksi}\sqrt{\text{in.}}$), (b) $27.5~\text{MPa}\sqrt{m}$ ($25~\text{ksi}\sqrt{\text{in.}}$), (c) $33~\text{MPa}\sqrt{m}$ ($30~\text{ksi}\sqrt{\text{in.}}$), and (d) $44~\text{MPa}\sqrt{m}$ ($40~\text{ksi}\sqrt{\text{in.}}$). Arrows show direction of macroscopic crack propagation.

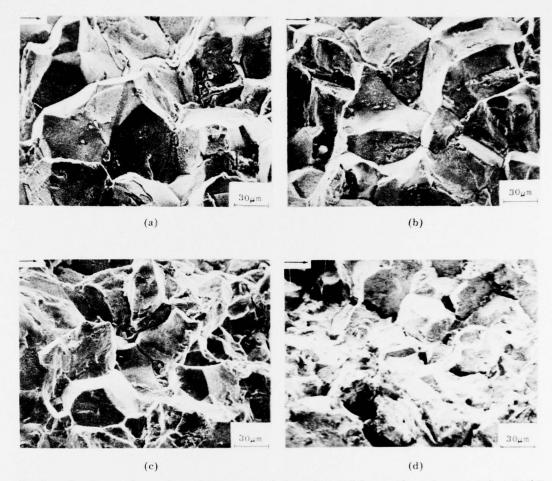
The striation spacings again correlate with the da/dN values calculated in the fatigue data analysis. The introduction of a 1-min hold time during the fatigue cycle caused the material to fail intergranularly for all values of ΔK . This is clearly evident in the SEM micrographs in Fig. 7. As mentioned earlier, there was some indication of a hold time effect at 593° C (1100° F) in the fatigue data, although the trend was not clearly outside the limits of experimental scatter. The SEM micrographs clearly show a change in microstructure and confirm the presence of a hold time effect.

Fig. 7 — Fracture surfaces of a solution-annealed Type 316 stainless steel specimen tested at 593° C (1100°F) with 1-min hold time. The SEM micrographs were taken at crack lengths that correspond to the following ΔK values: (a) $22 \text{ MPa}\sqrt{\text{in.}}$), (b) $27.5 \text{ MPa}\sqrt{\text{m}}$ (25 ksi $\sqrt{\text{in.}}$), (c) 33 MPa $\sqrt{\text{m}}$ (30 ksi $\sqrt{\text{in.}}$), and (d) 44 MPa $\sqrt{\text{m}}$ (40 ksi $\sqrt{\text{in.}}$). Arrows show direction of macroscopic crack propagation. Micrographs show that the failure mode was mostly intergranular for all ΔK values.

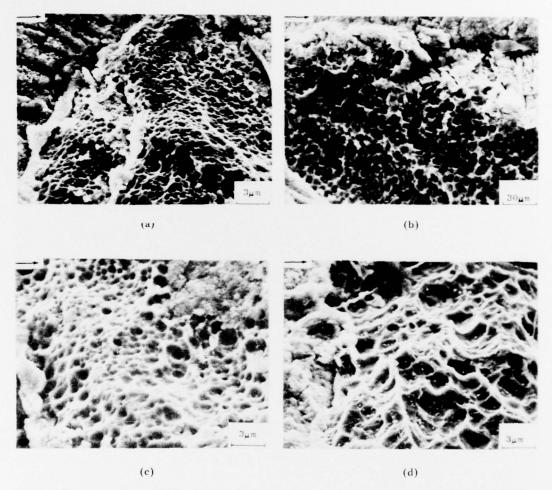
Typical SEM micrographs of the zero hold time specimens are shown in Fig. 8a and 8b of the 1-min hold time specimens in Fig. 8c and 8d. The failure mode is transgranular but of a different nature than that observed for the test and material conditions previously described. The fracture surface shows features of microvoid coalescense, which is typical of a ductile rupture failure process. Inclusions, probably the carbide precipitates formed during aging, can be clearly seen in all panels of Fig. 8 as the light-colored features in the center of the microvoids. The microvoids appear to be larger in the specimen tested with 1-min hold time.

Fig. 8 — Fracture surfaces (SEM) of solution-annealed, thermally aged Type 316 stainless steel specimens tested at 593°C (1100°F). Specimens (a) and (b) were tested with zero hold time; (c) and (d) were tested with 1-min hold time. The SEM micrographs were taken at crack lengths that correspond to the following ΔK values: (a) $22 \text{ MPa}\sqrt{m}$ ($20 \text{ ksi}\sqrt{\text{in.}}$), (b) $27.5 \text{ MPa}\sqrt{m}$ ($25 \text{ ksi}\sqrt{\text{in.}}$), (c) $22 \text{ MPa}\sqrt{m}$ ($26 \text{ ksi}\sqrt{\text{in.}}$), and (d) $27.5 \text{ MPa}\sqrt{m}$ ($26 \text{ ksi}\sqrt{\text{in.}}$). Arrows show direction of macroscopic crack propagation. For both sets of test conditions the micrographs show that specimens failed transgranularly by microvoid coalesence. In the case of 1-min hold time, the void size tends to increase with higher ΔK value.

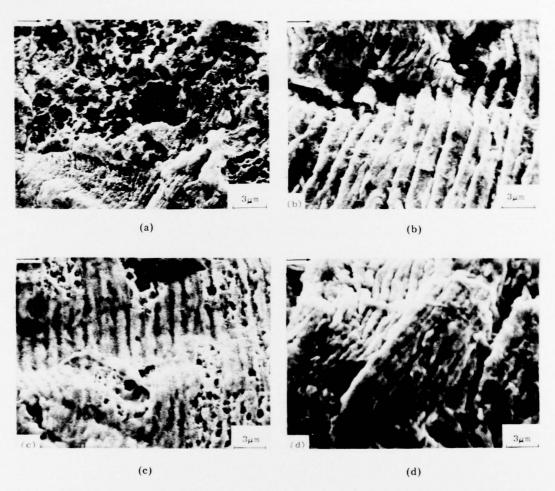
The voids also tend to increase in size with increasing ΔK . The basic fatigue features are the same in both specimens. That is, wherever the oxide layer has been removed by the cleaning process, microvoids can be seen (Fig. 8a-8d, 9a and 9c). In contrast, where the oxide layer still covers the fracture surface, striations are visible, especially in the later stages of crack growth when the ΔK values are high (Fig. 9b and d). The striation spacings compare quite well with the corresponding crack growth rates in the mechanical data.

Fig. 9 — SEM micrographs of a solution-annealed thermally aged Type 316 stainless steel specimen tested at 593° C (1100° F). Specimens (a) and (b) were tested with no bold time; (c) and (d) were tested with bold time. The micrographs were taken at crack lengths corresponding to the following ΔK values: (a) $37.5 \text{ MPa}\sqrt{\text{m}}$ ($35 \text{ ksi}\sqrt{\text{in.}}$), (b) $44 \text{ MPa}\sqrt{\text{m}}$ ($40 \text{ ksi}\sqrt{\text{in.}}$), (c) $47.5 \text{ MPa}\sqrt{\text{m}}$ ($40 \text{ ksi}\sqrt{\text{in.}}$), and (d) $44 \text{ MPa}\sqrt{\text{m}}$ (40 ksi $\sqrt{\text{in.}}$), Arrows show direction of macroscopic stack propagation. Microvoids can be seen wherever the oxide layer has been removed. Clear striations are visible where the oxide layer still covers the fracture surface.
